Dam Safety Management of Council Dams in New South Wales, Australia, including two Case Studies

Paul Heinrichs

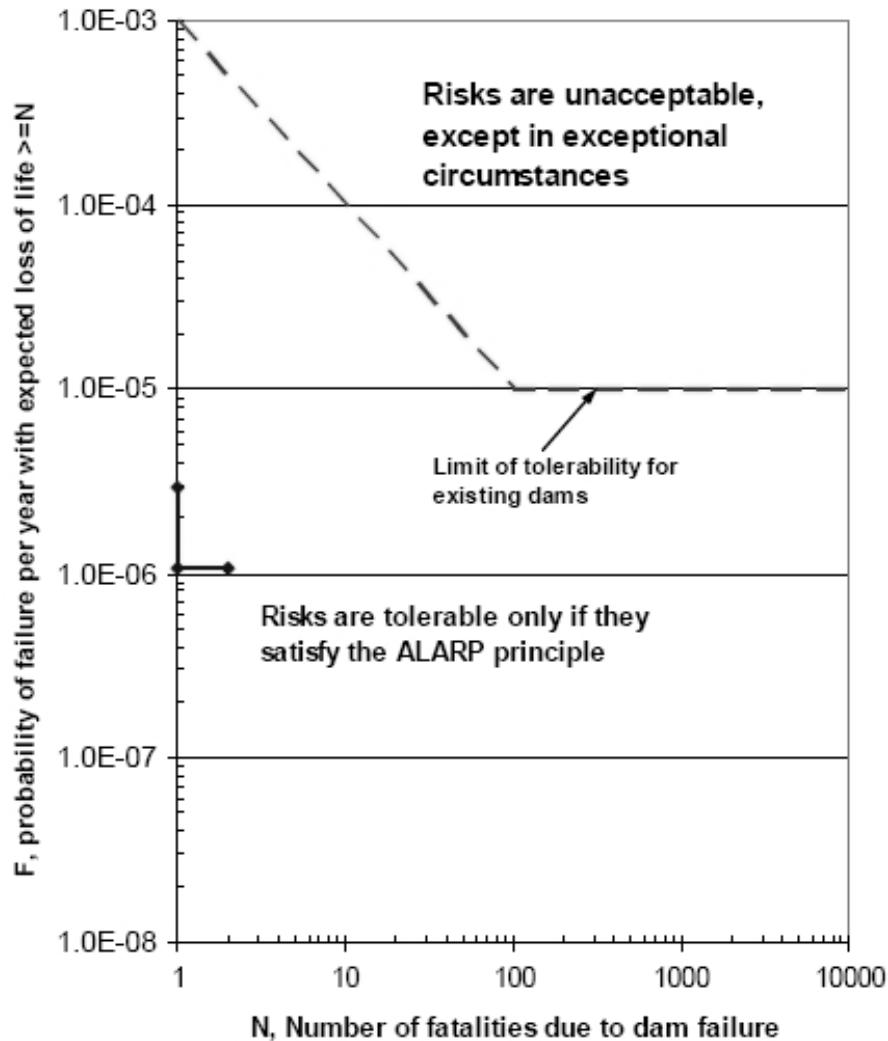
Figure 1: ANCOLD Societal Risk Guideline: Existing dams

Loss of life was estimated as one for piping, and two for overtopping. When the risk cases were plotted on the ANCOLD Societal Risk Criteria **Figure [1]**, it was found that the risks were tolerable, and no upgrading was needed.
